**STATEMENT OF UNSAFE OR DANGEROUS STRUCTURE (K.S.A. 12-1750)
LOCATED AT 413 SOUTH CHERRY STREET, OLATHE, KANSAS**

Re: Structural Condition Assessment
413 S Cherry St
Olathe, KS 66061

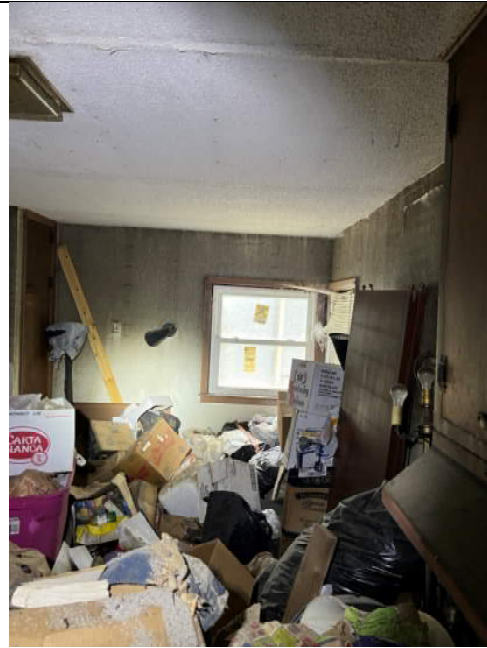
The majority of the interior of the house is crowded with the homeowner's possessions that are, in some areas, piled to head height. The density of the contents of the house was very limiting in observing the kitchen, rear entry room, dining room, southeast bedroom, and southwest bedroom. Some of the contents had been removed before Apex's arrival on-site to allow for some visibility of the floor's surface. (Ref photos 1-4)

Photo 2: Contents of the residence

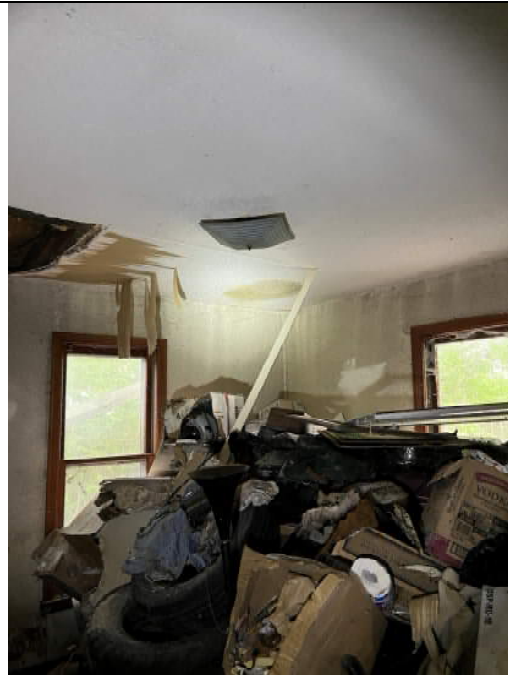
Photo 4: Contents of the residence

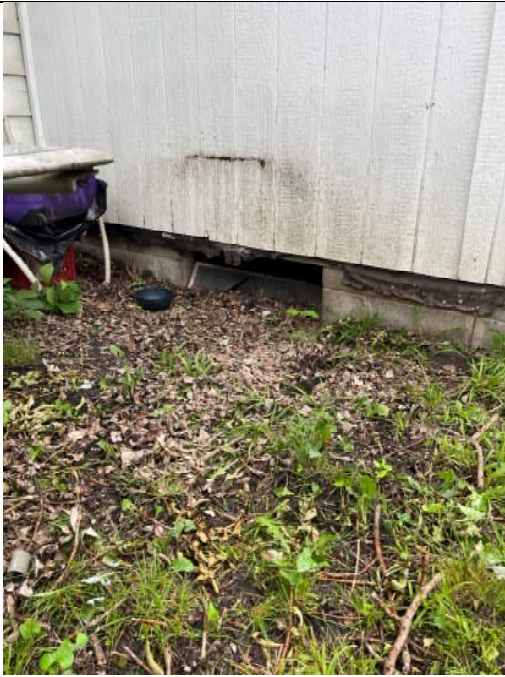
Access to the crawl space was limited to two narrow openings on the east side of the house. Entrance was not possible due to the narrow height of the openings, but a limited visible inspection was performed. (Ref photos 5 & 6) The observable structure was recorded on the sketches found at the end of Appendix A.

Photo 5: Crawl space access

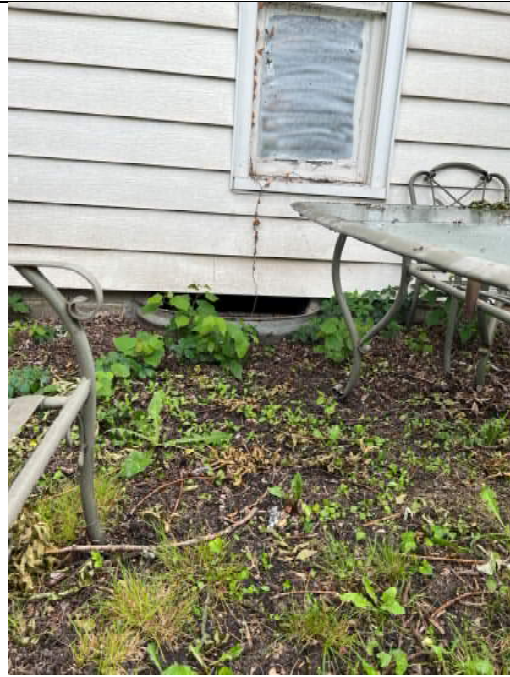
Photo 6: Crawl space access

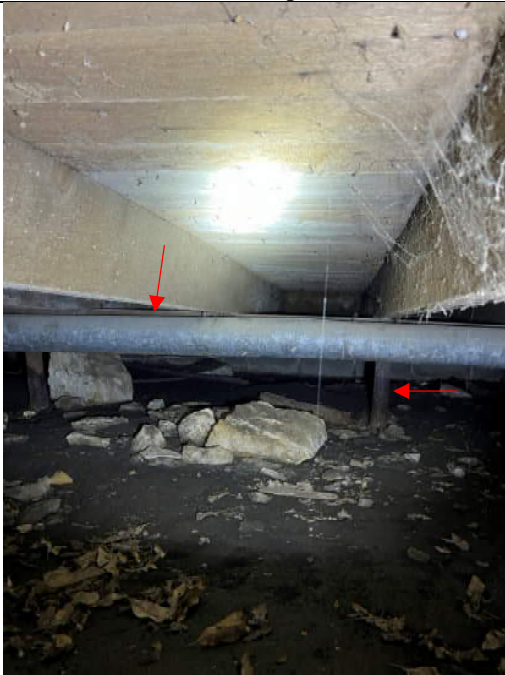
The floor framing in the northeast wing of the house was composed of 2x8 joists at 24" OC with a dropped beam at mid-span supported periodically by small steel pipe columns. The beam was not visible due to a smaller diameter pipe being located in front of it. It appears that the beam is composed of built-up 2x4s. It's not clear whether or not the pipe columns are supported on footings. To the west, a rectangular duct blocks visibility of the west half of the framing, but it can be seen that the south ends of the joists are discontinuous and that to the west of the jog in the east wall it's unclear whether or not the joists are supported by a beam. The remnants of an old stone foundation appear to be left behind. It's unclear whether or not those stones remain in service as part of the foundation. (Ref photos 7 & 8)

Photo 7: Northeast wing framing. Note the beam and short post

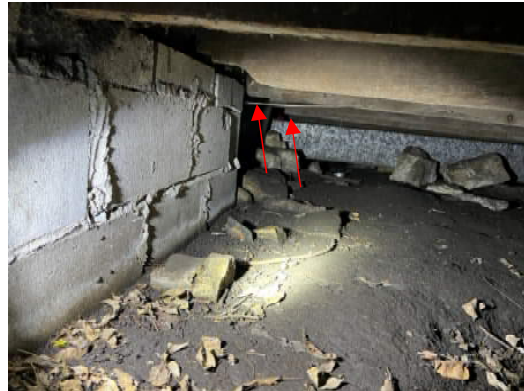
Photo 8: Unsupported floor joists ends

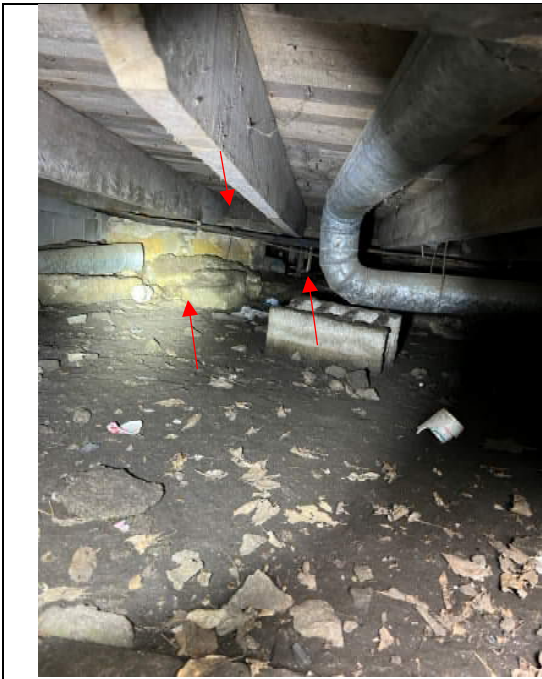
Through the southmost crawl space opening it can be seen that the joists span east to west and the near span is supported by a flush beam in the floor system. Past the flush beam, the floor framing was difficult to observe. More stone remnants are visible. Adjustable metal jacks can be seen throughout this wing of the residence supporting individual joists. The jacks may be supported by small foundation elements. (Ref photos 9 & 10)

Photo 9: Southeast wing framing. Note the flush beam, stone remnants, and jack post

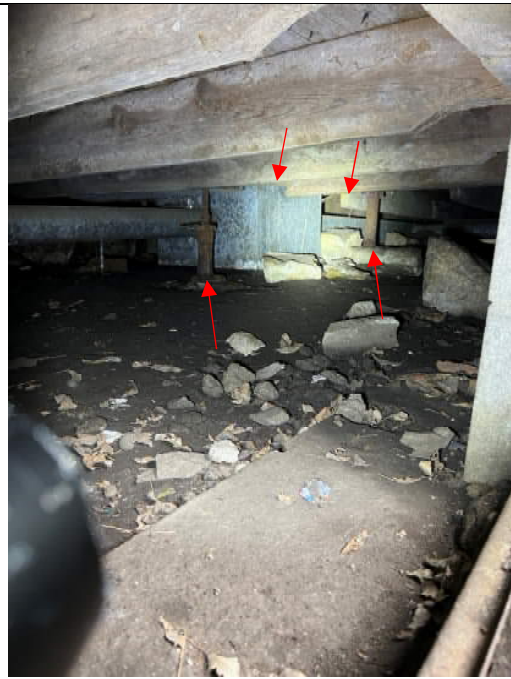
Photo 10: Jack posts, unsupported joists from an alternative angle, and a cut joist

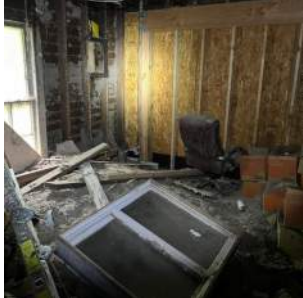
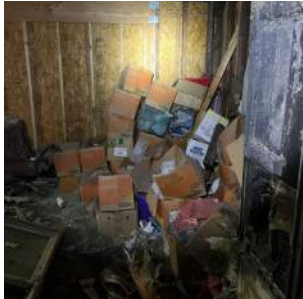
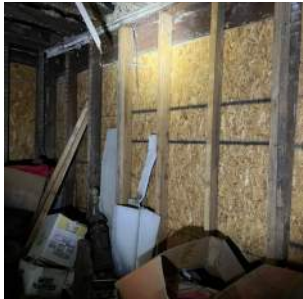
Number	Floor	Unknown	Description	Photos
1	First		The wall framing in the clouded area has been repaired due to fire damage, according to an Olathe building official.

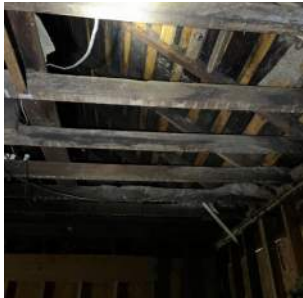
2			The gypsum board ceiling has collapsed in the clouded area leaving the top side of the floor covered in gypsum board and insulation. The ceiling and roof framing is visible in this area and appears to be mostly intact and was spared any major fire damage. No charring was observed in the members. Some older previous repairs were observed and appear to have been done to address fungal decay in several of the rafters and roof sheathing.

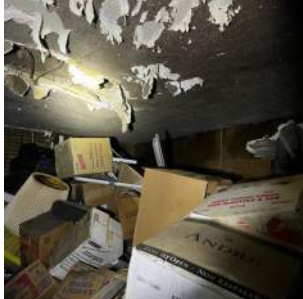
The ceiling above the northwest corner of the dining room that is deflecting downward significantly appears to be at risk of collapse along with the floor in the southeast corner of the dining room that is deflecting downward.

3	First		<p>The ceiling within the clouded area has a visible downward sag. The roof framing above was not able to be viewed due to the contents of the home.</p>

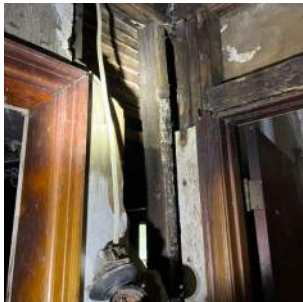
4	First		<p>A hole in both the roof and ceiling framing was observed in the clouded area. Decaying ceiling and wall framing was observed around the opening. The surface of the floor below was observed to be wet and covered with organic material below the opening.</p>

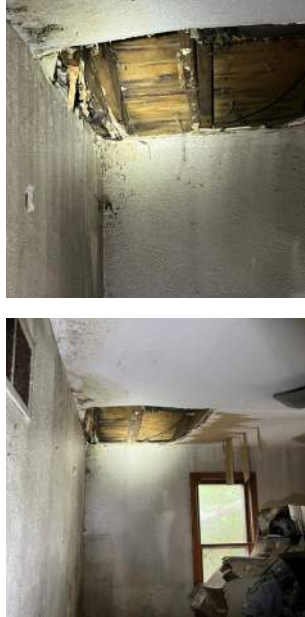
Number	Floor	Unknown	Description	Photos
5			<p>A hole was observed in the ceiling in the clouded area. Some of the rafters were observed to be decayed, but a hole in the roof wasn't able to be observed directly because the floor in the area directly below the hole did not appear to be safe to access.</p>

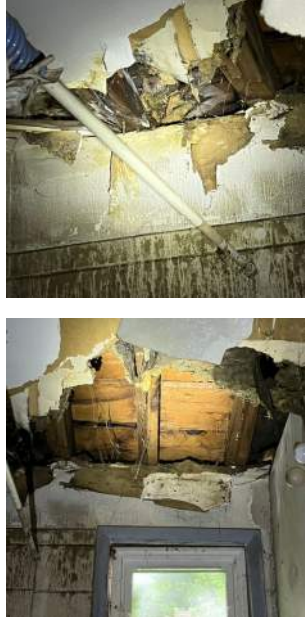
6			<p>A hole was observed in the ceiling in the clouded area. Some of the rafters were observed to be decayed, but a hole in the roof wasn't able to be observed directly because the floor in the area directly below the hole did not appear to be safe to access.</p>

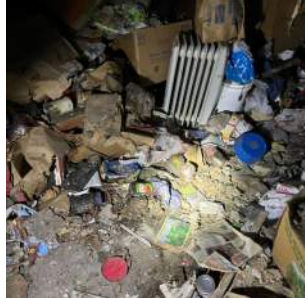
Number	Floor	Unknown	Description	Photos
7	First		The first floor framing in this area is visibly, significantly deflected downward. The contents of the house obscure the the floor to the north of the area making the full extent of the deflection unclear.

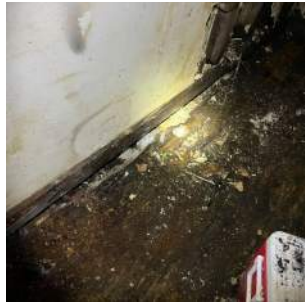
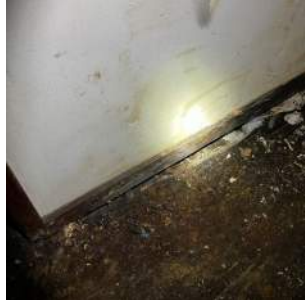
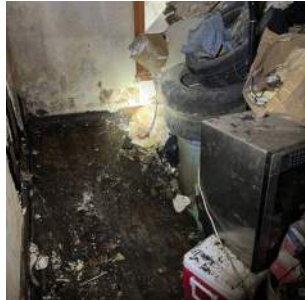
Some of the structural deficiencies identified in the Observations section (including Appendix A) above constitute partial collapse or lacking necessary support of the ground. The deflection observed in the floor framing in the southwest bedroom appears to be significant enough that the framing members may have collapsed into the crawl space and rested on the grade below. The structure near the center of the house, as viewed from the crawl space access locations, does not appear to have a complete load path, and some of the members appear to have been modified in a way that alters the load path.

8			The floor in the clouded area below the partition wall between the bathroom and southwest bedroom is substantially deflected and may be reasonably consider to have effectively collapsed down into the crawl space below. A large gap of 6" or more was observed below the partition separating the two rooms and the top of the floor's surface. The floor within the southwest bedroom was only visible at the east end of the room. The floor's surface to the west was obscured by the contents of the house.
