**STATEMENT OF UNSAFE OR DANGEROUS STRUCTURE (K.S.A. 12-1750)  
LOCATED AT 414 EAST CEDAR STREET, OLATHE, KANSAS**

414 E Cedar St - Structural Assessment

414 E Cedar St  
OLATHE, KS 66061-4762

2026.04.14

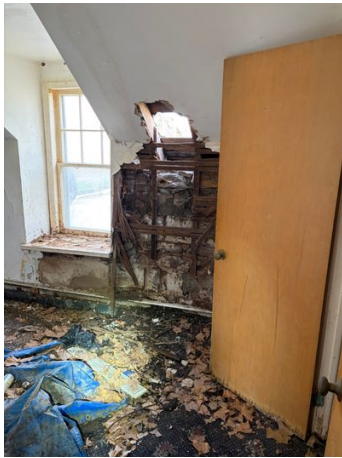
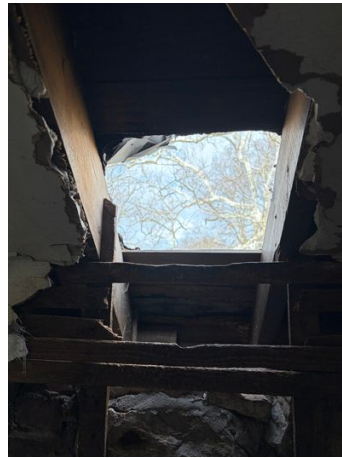
- Deterioration of the roof framing was observed at the northeast, northwest, southeast, and southwest corners of the original portion of the building. Openings were observed in the roof framing at these locations. The roof sheathing, rafters, furred wood wall framing, and rubble stone masonry walls were observed to have deteriorated in these areas. (Ref images 1-9)

Image: 1: Deterioration at the southwest corner of the roof

Image: 2: Deterioration at the southwest corner of the roof

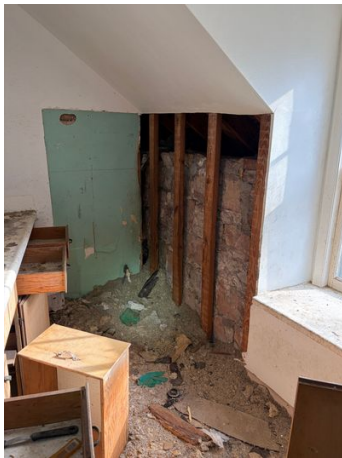
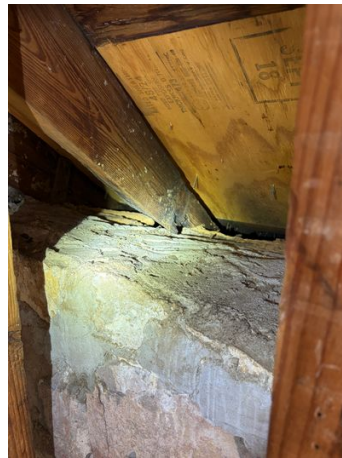
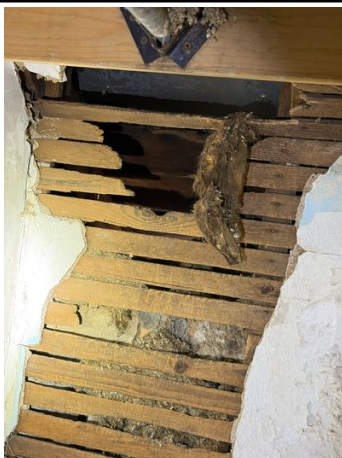
Image: 3: Deterioration at the southeast corner of the roof

Image: 4: Deterioration at the southeast corner of the roof

Image: 5: Deterioration at the southeast corner of the roof

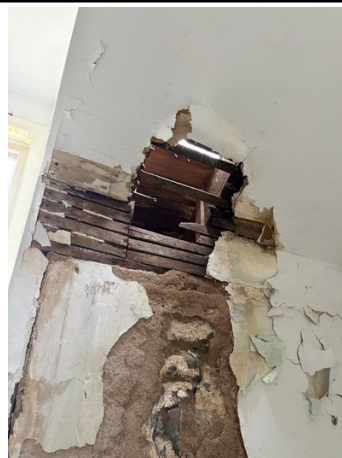
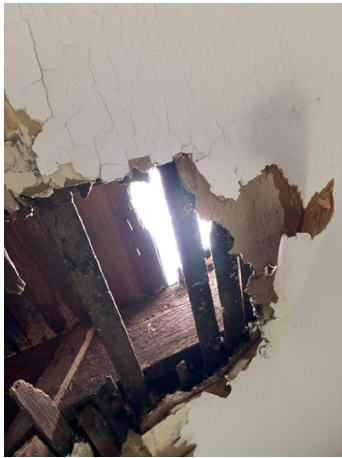
Image: 6: Deterioration at the northwest corner of the roof

Image: 7: Deterioration at the northwest corner of the roof

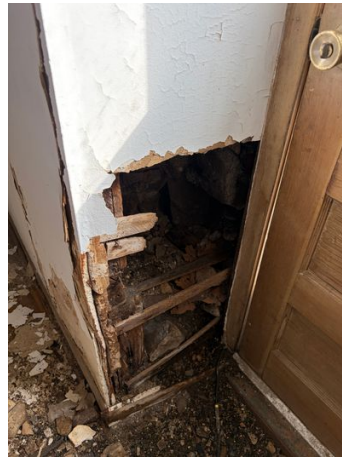
Image: 8: Deterioration at the northeast corner of the roof

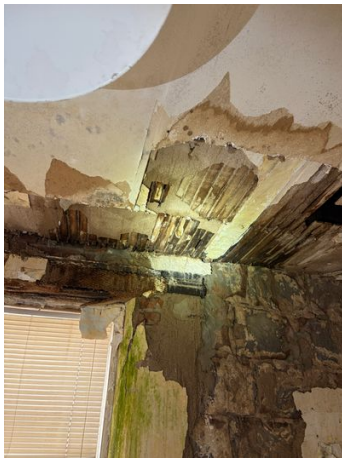
Image: 9: Floor framing deterioration below identified roof openings

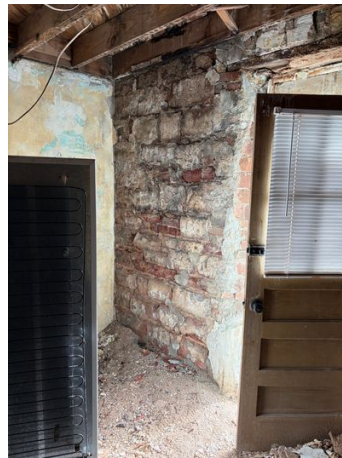
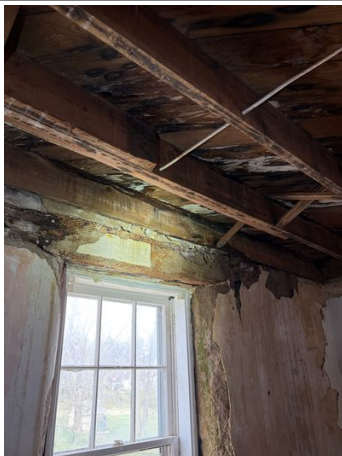
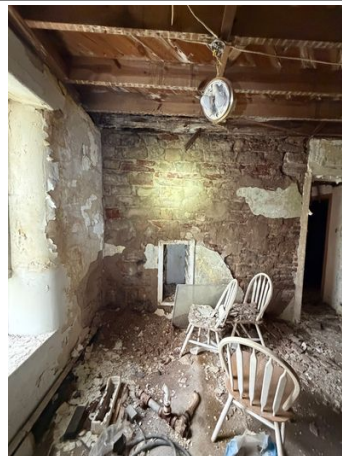
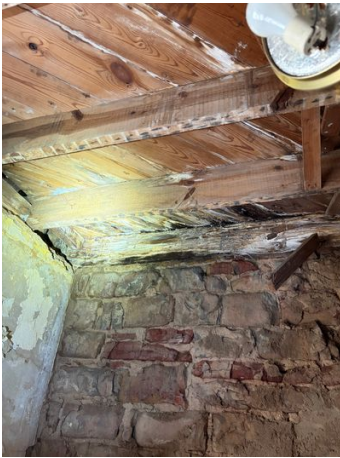
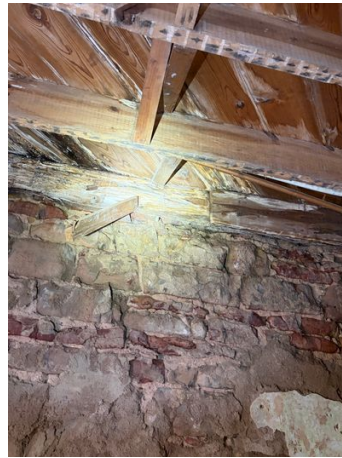
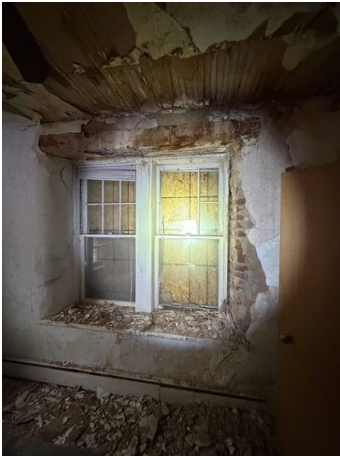
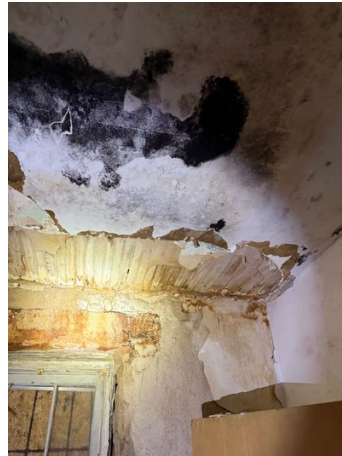
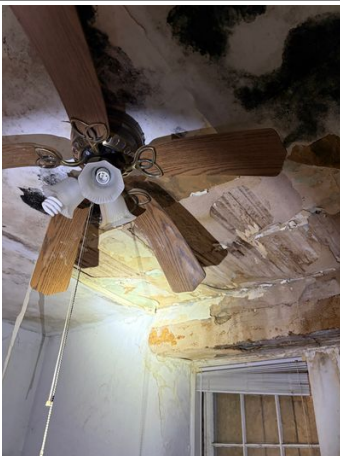
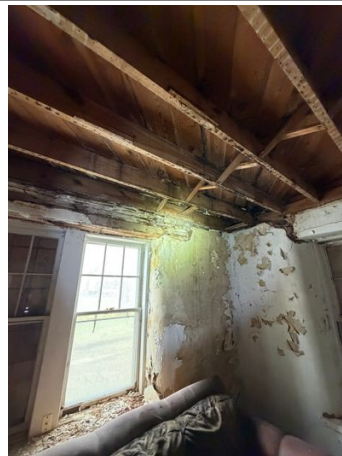
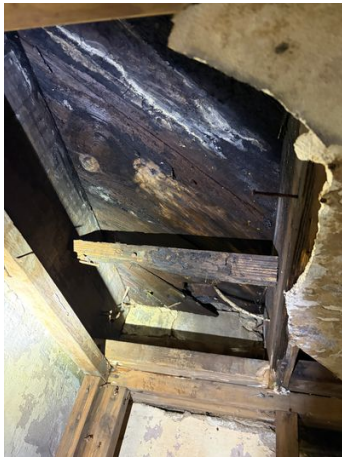
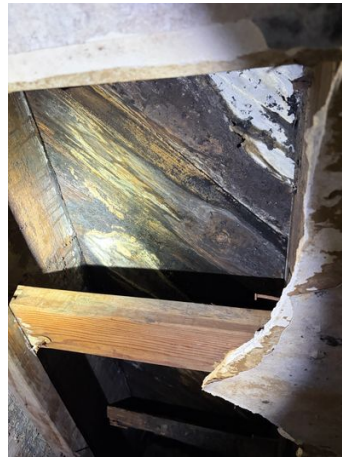
- At the first, second, and third floor levels below the observed openings at the northeast, northwest, and southwest corners of the original portion of the building, deterioration was observed in the floor framing including the sheathing, joists, window opening headers, wall furring, and rubble stone masonry walls. (Ref images 10-20)

Image: 10: Floor framing deterioration below identified roof openings

Image: 11: Floor framing deterioration below identified roof openings

Image: 12: Floor framing deterioration below identified roof openings

Image: 13: Floor framing deterioration below identified roof openings

Image: 14: Floor framing deterioration below identified roof openings

Image: 15: Floor framing deterioration below identified roof openings

Image: 16: Floor framing deterioration below identified roof openings

Image: 17: Floor framing deterioration below identified roof openings

Image: 18: Floor framing deterioration below identified roof openings

Image: 19: Floor framing deterioration below identified roof openings

Image: 20: Floor framing deterioration below identified roof openings

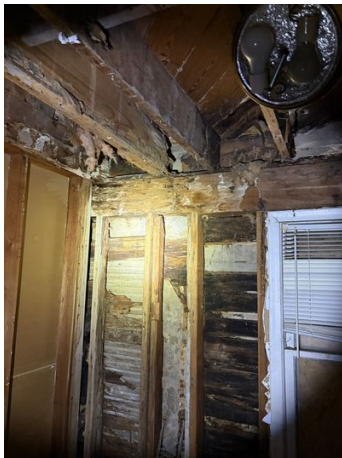
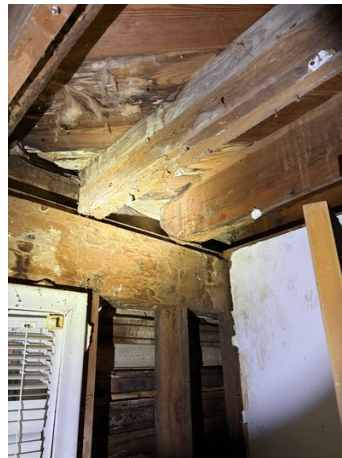
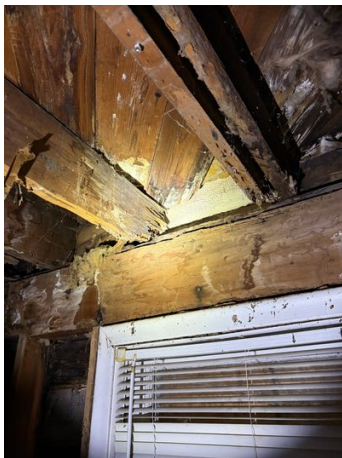
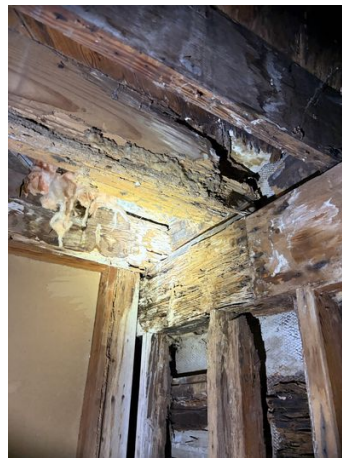
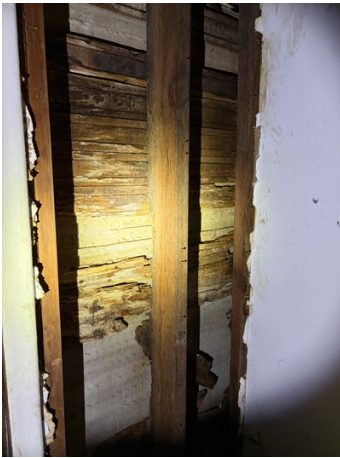
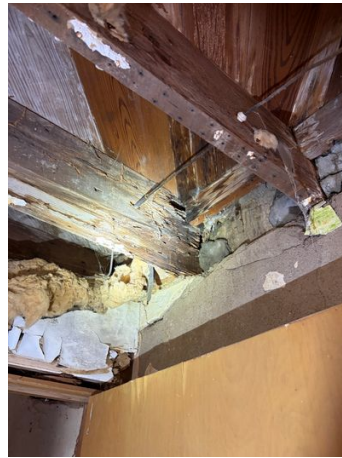
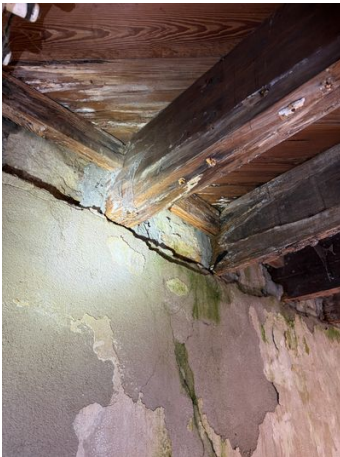
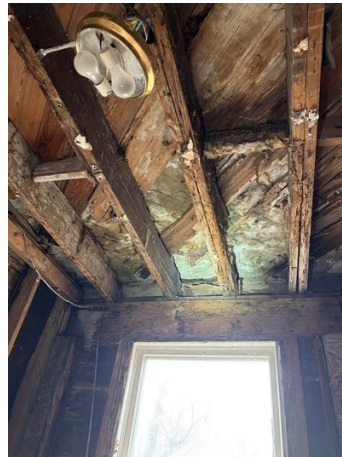
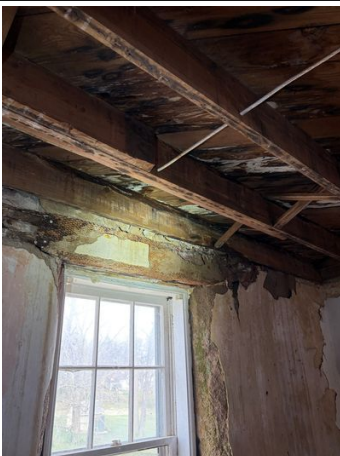
- Severe deterioration of the roof framing was observed in the northern section of the single story addition on the east side of the building. The joists and sheathing were observed to be saturated and deteriorated due to fungal decay and insect attack. Large portions of the joists' section were observed to be missing at bearing locations at the east and west ends of the joists. Water ponding was observed on the roof above and actively dripping water was observed at the northeast corner of the addition. (Ref images 21-30)

- Severe deterioration of the east wall of the northern portion of the addition was observed. The wall plates and studs were observed to be saturated and deteriorated due to fungal decay and insect attack. Large portions of the wall sheathing were observed to have completely decayed away. (Ref images 21-30)

Image: 21: North addition framing deterioration

Image: 22: North addition framing deterioration

Image: 23: North addition framing deterioration

Image: 24: North addition framing deterioration

Image: 25: North addition framing deterioration

Image: 26: North addition framing deterioration

Image: 27: North addition framing deterioration

Image: 28: North addition framing deterioration

Image: 29: North addition framing deterioration

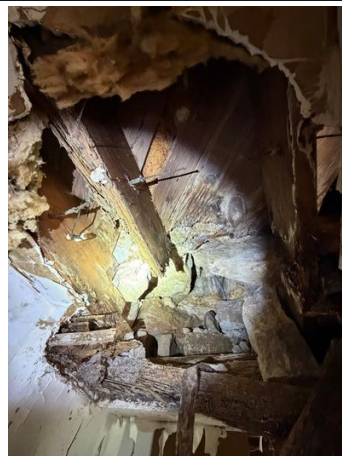
- The wood headers supporting the opening between the northern portion of the addition and the original portion of the building were observed to be severely decayed. (Ref image 30)

Image: 30: North addition framing deterioration

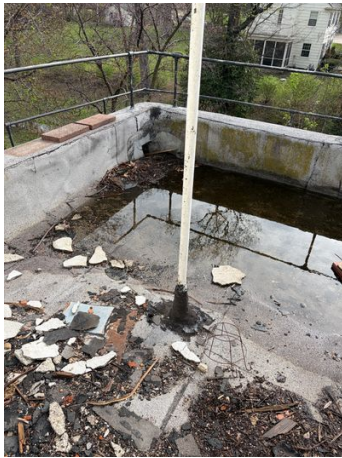
Image: 31: North addition roof ponding

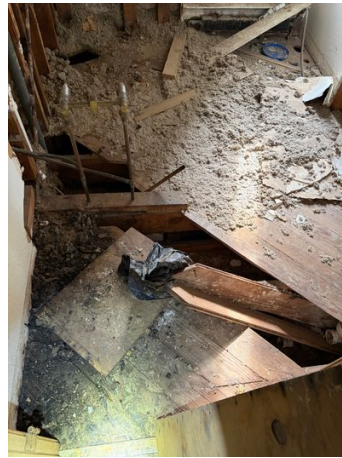
- Partially removed floor sheathing in a third floor bathroom due to an apparent unfinished renovation. (Ref image 32)

Image: 32: Missing floor sheathing

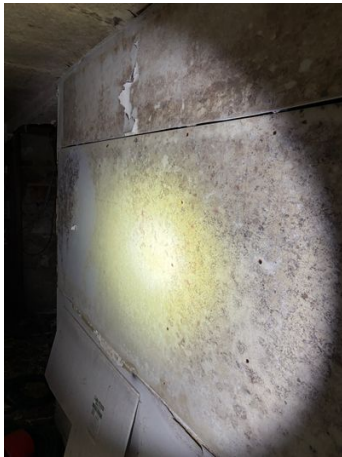
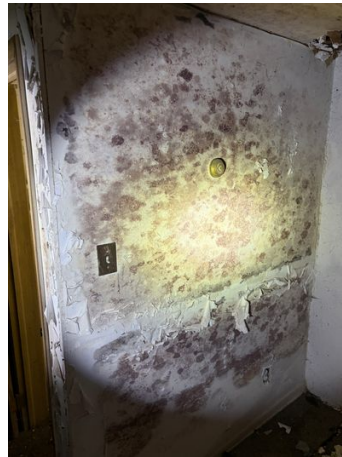
- Cracking of exterior stucco cladding.
- Visible deflection of floor and ceiling framing throughout the building.
- Damage to wall, ceiling, and floor finishes was observed throughout the building. Including partially and completely detached plaster and lath, cracking of plaster finishes, and water staining of finishes.
- Mold, animal feces, and debris was observed to be covering many surfaces throughout the house. (Ref images 33-39)

Image: 33: Mold covered wall finishes

Image: 34: Mold covered wall finishes

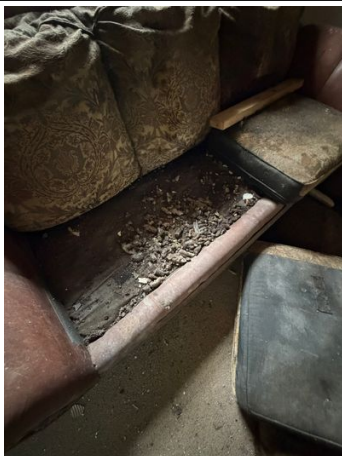
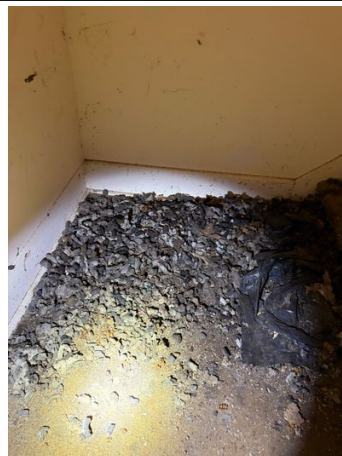
Image: 35: Animal Feces

Image: 36: Animal Feces

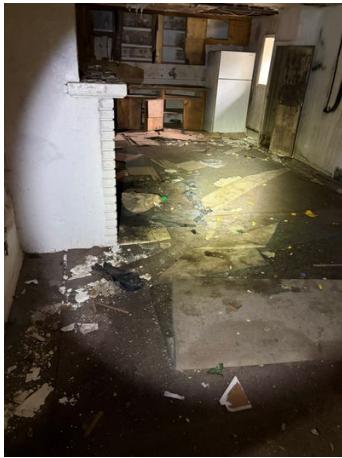
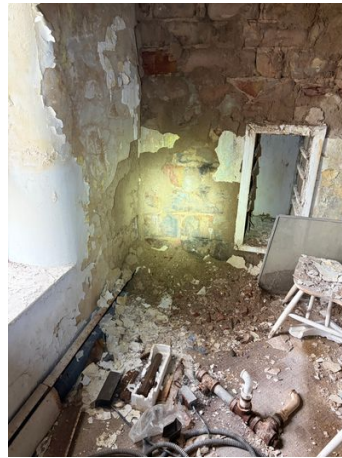
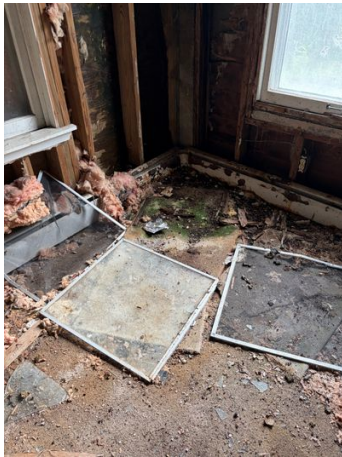
Image: 37: Debris covered floors

Image: 38: Debris covered floors

Image: 39: Debris covered floors
