**STATEMENT OF UNSAFE OR DANGEROUS STRUCTURE (K.S.A. 12-1750)
LOCATED AT 414 EAST CEDAR STREET, OLATHE, KANSAS**

414 E Cedar St - Structural Assessment

414 E Cedar St
OLATHE, KS 66061-4762

2026.04.14

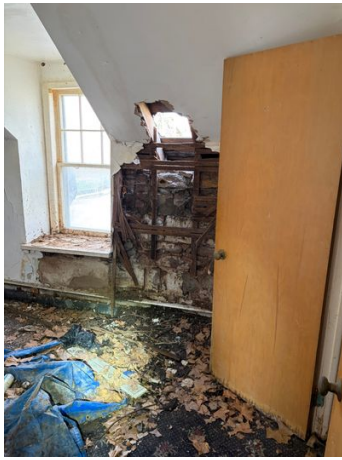
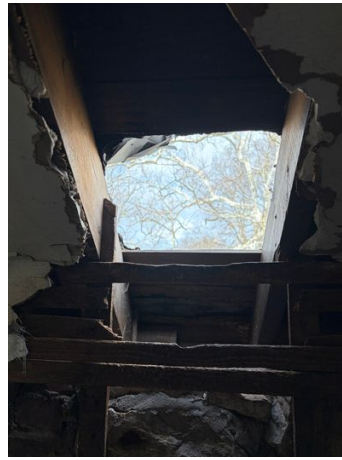
- Deterioration of the roof framing was observed at the northeast, northwest, southeast, and southwest corners of the original portion of the building. Openings were observed in the roof framing at these locations. The roof sheathing, rafters, furred wood wall framing, and rubble stone masonry walls were observed to have deteriorated in these areas. (Ref images 1-9)

Image: 1: Deterioration at the southwest corner of the roof

Image: 2: Deterioration at the southwest corner of the roof

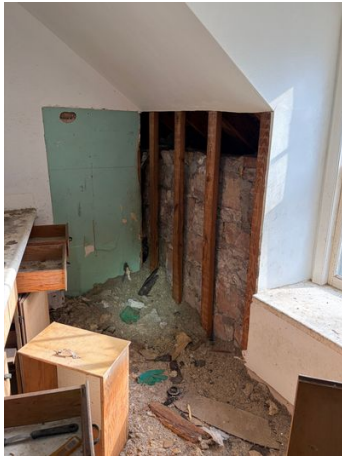
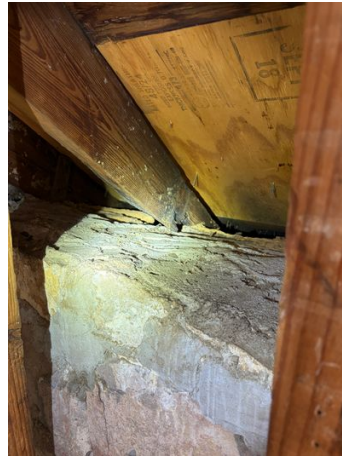
Image: 3: Deterioration at the southeast corner of the roof

Image: 4: Deterioration at the southeast corner of the roof

Image: 5: Deterioration at the southeast corner of the roof

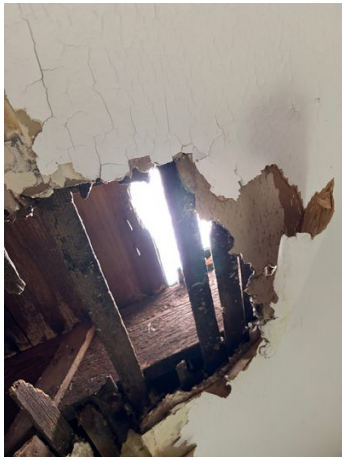
Image: 6: Deterioration at the northwest corner of the roof

Image: 7: Deterioration at the northwest corner of the roof

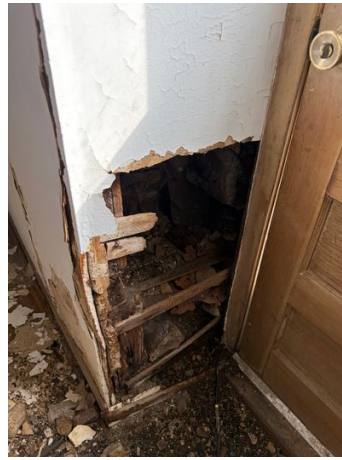
Image: 8: Deterioration at the northeast corner of the roof

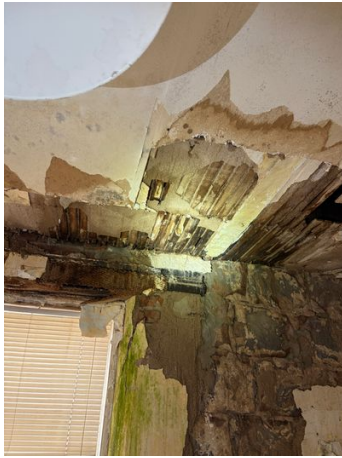
Image: 9: Floor framing deterioration below identified roof openings

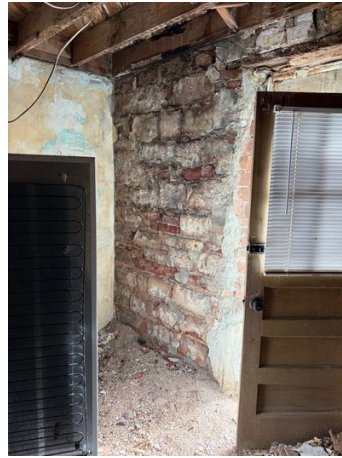
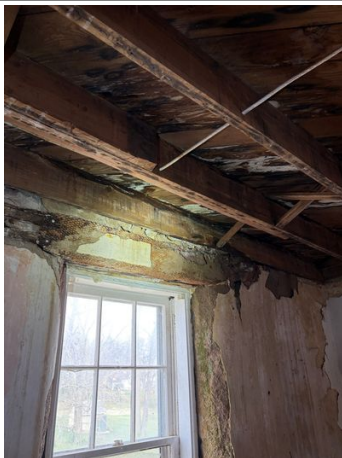
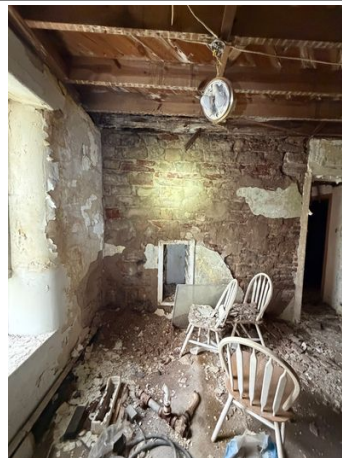
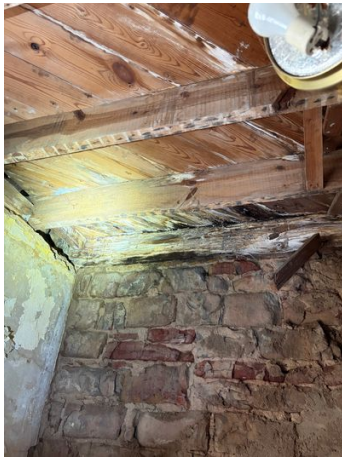
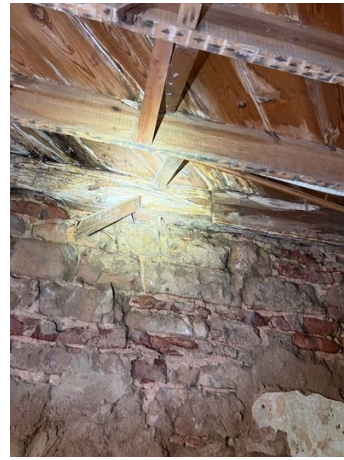
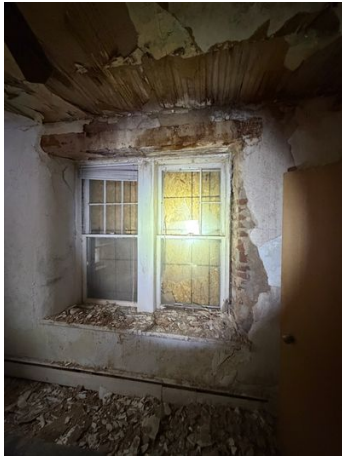
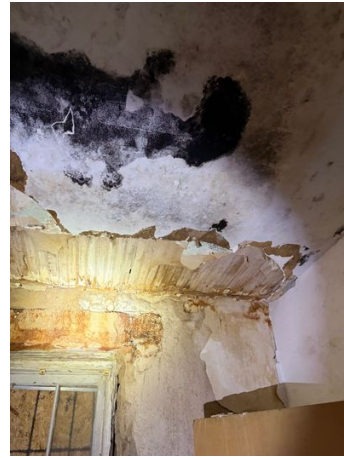
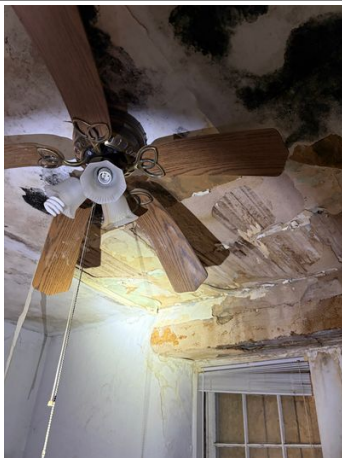
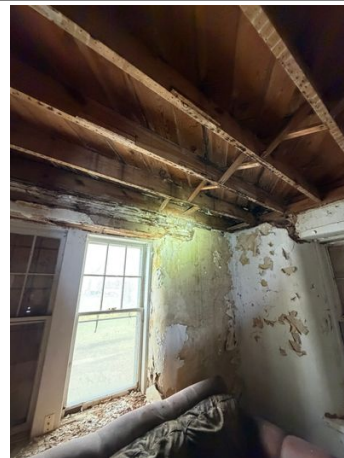
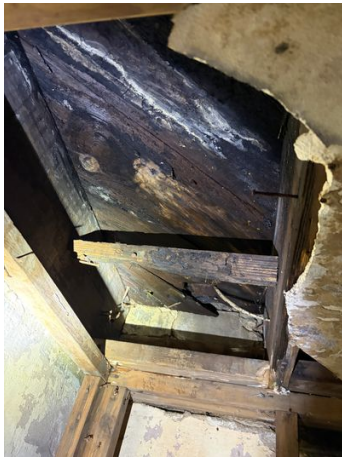
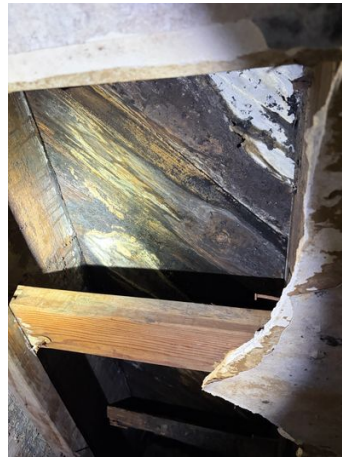
- At the first, second, and third floor levels below the observed openings at the northeast, northwest, and southwest corners of the original portion of the building, deterioration was observed in the floor framing including the sheathing, joists, window opening headers, wall furring, and rubble stone masonry walls. (Ref images 10-20)

Image: 10: Floor framing deterioration below identified roof openings

Image: 11: Floor framing deterioration below identified roof openings

Image: 12: Floor framing deterioration below identified roof openings

Image: 13: Floor framing deterioration below identified roof openings

Image: 14: Floor framing deterioration below identified roof openings

Image: 15: Floor framing deterioration below identified roof openings

Image: 16: Floor framing deterioration below identified roof openings

Image: 17: Floor framing deterioration below identified roof openings

Image: 18: Floor framing deterioration below identified roof openings

Image: 19: Floor framing deterioration below identified roof openings

Image: 20: Floor framing deterioration below identified roof openings

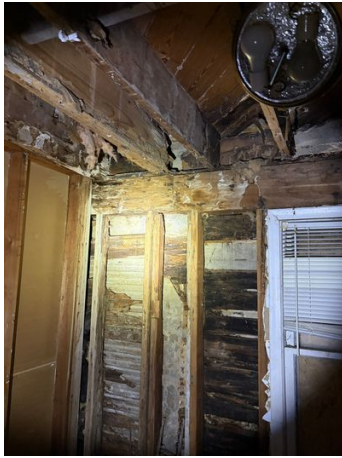
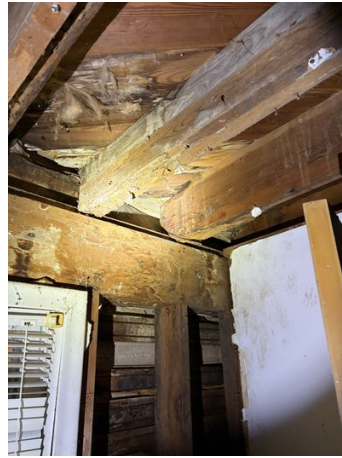
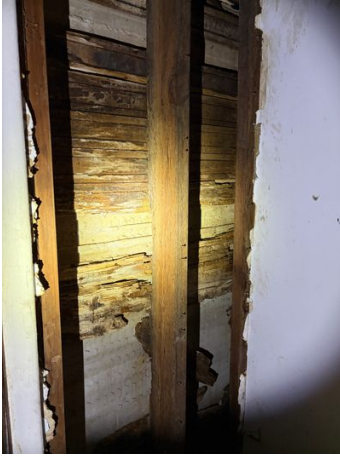
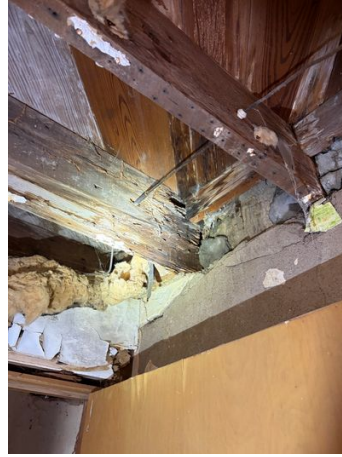
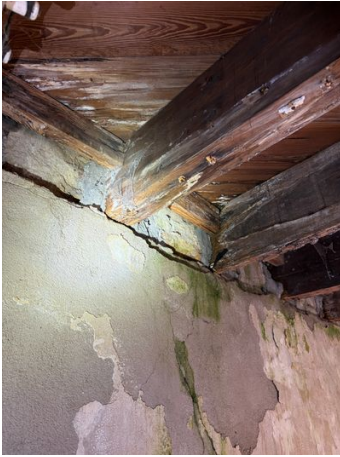
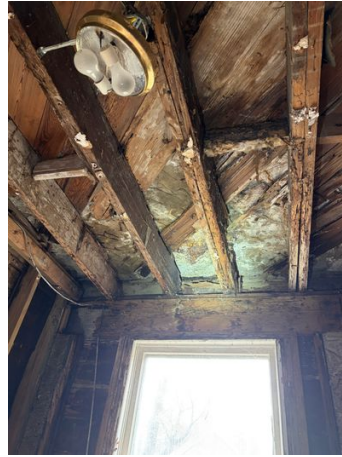
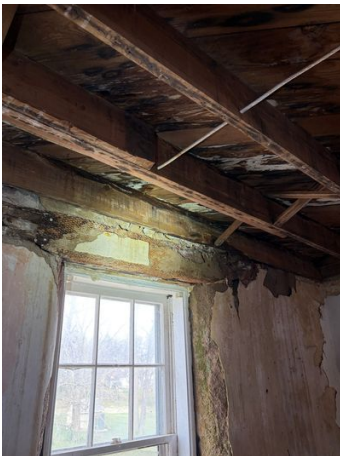
- Severe deterioration of the roof framing was observed in the northern section of the single story addition on the east side of the building. The joists and sheathing were observed to be saturated and deteriorated due to fungal decay and insect attack. Large portions of the joists' section were observed to be missing at bearing locations at the east and west ends of the joists. Water ponding was observed on the roof above and actively dripping water was observed at the northeast corner of the addition. (Ref images 21-30)

- Severe deterioration of the east wall of the northern portion of the addition was observed. The wall plates and studs were observed to be saturated and deteriorated due to fungal decay and insect attack. Large portions of the wall sheathing were observed to have completely decayed away. (Ref images 21-30)

Image: 21: North addition framing deterioration

Image: 22: North addition framing deterioration

Image: 23: North addition framing deterioration

Image: 24: North addition framing deterioration

Image: 25: North addition framing deterioration

Image: 26: North addition framing deterioration

Image: 27: North addition framing deterioration

Image: 28: North addition framing deterioration

Image: 29: North addition framing deterioration

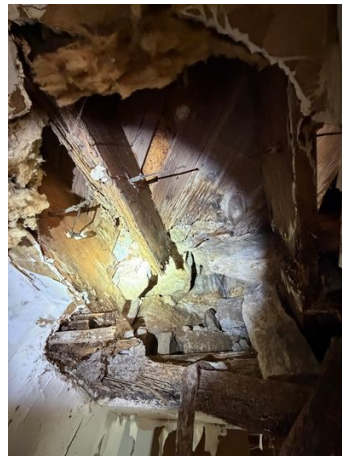
- The wood headers supporting the opening between the northern portion of the addition and the original portion of the building were observed to be severely decayed. (Ref image 30)

Image: 30: North addition framing deterioration

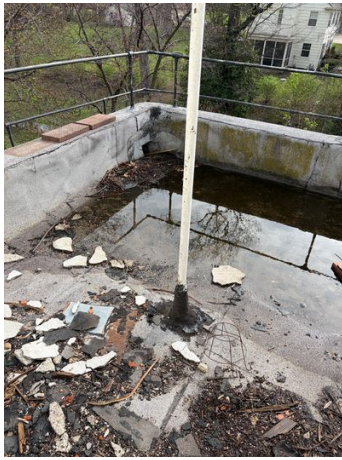
Image: 31: North addition roof ponding

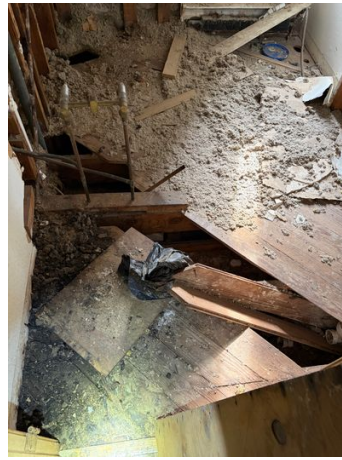
- Partially removed floor sheathing in a third floor bathroom due to an apparent unfinished renovation. (Ref image 32)

Image: 32: Missing floor sheathing

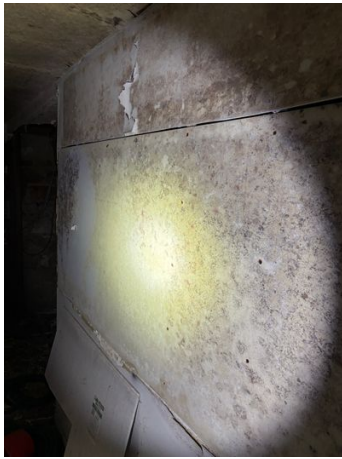
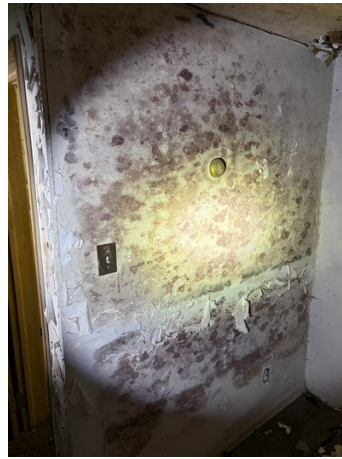
- Cracking of exterior stucco cladding.
- Visible deflection of floor and ceiling framing throughout the building.
- Damage to wall, ceiling, and floor finishes was observed throughout the building. Including partially and completely detached plaster and lath, cracking of plaster finishes, and water staining of finishes.
- Mold, animal feces, and debris was observed to be covering many surfaces throughout the house. (Ref images 33-39)

Image: 33: Mold covered wall finishes

Image: 34: Mold covered wall finishes

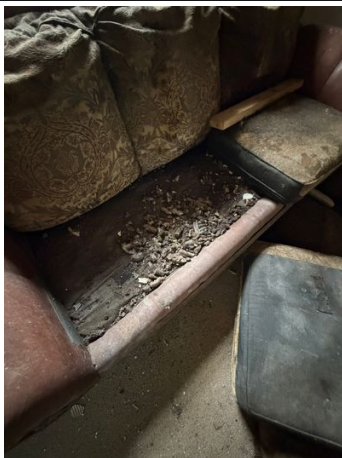
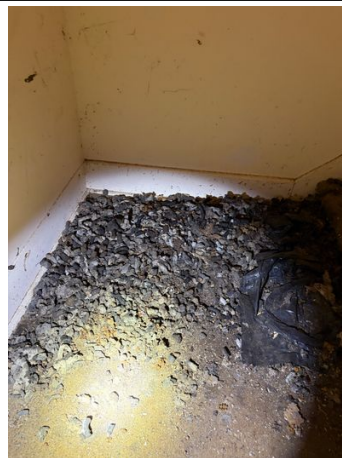
Image: 35: Animal Feces

Image: 36: Animal Feces

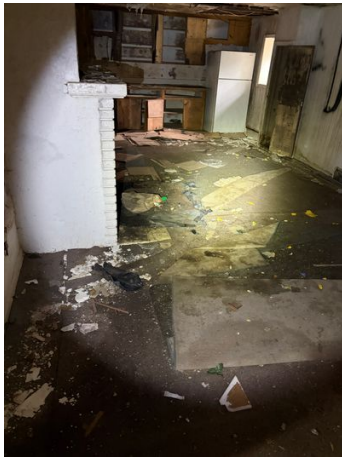
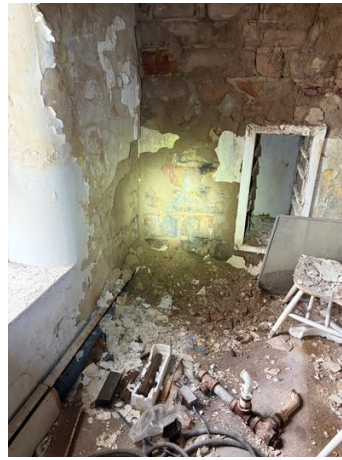
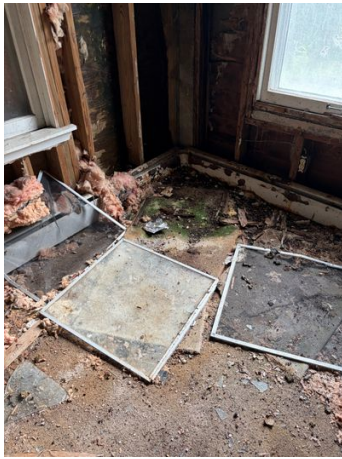
Image: 37: Debris covered floors

Image: 38: Debris covered floors

Image: 39: Debris covered floors
