**STATEMENT OF UNSAFE OR DANGEROUS STRUCTURE (K.S.A. 12-1750)  
LOCATED AT 413 SOUTH CHERRY STREET, OLATHE, KANSAS**

Re: Structural Condition Assessment  
413 S Cherry St  
Olathe, KS 66061

## Appendix A: Site Observations

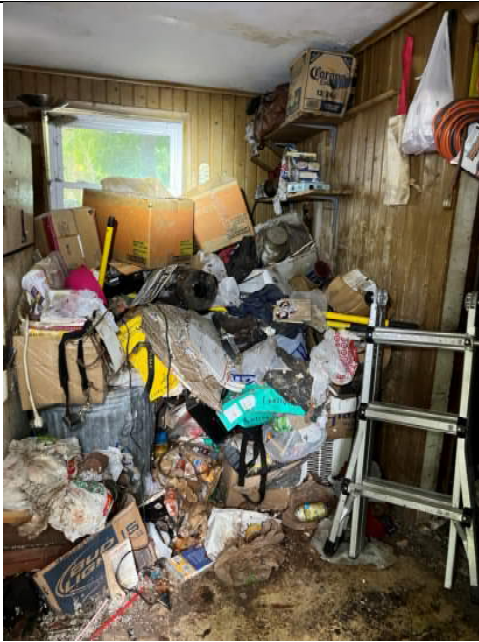
Photo 1: Contents of the residence

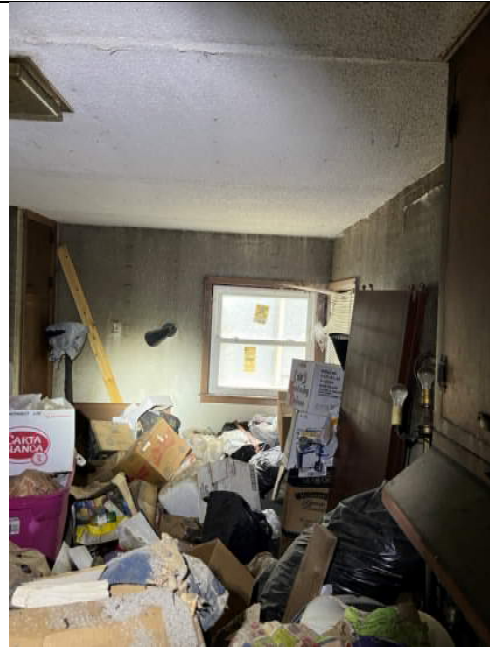
Photo 2: Contents of the residence

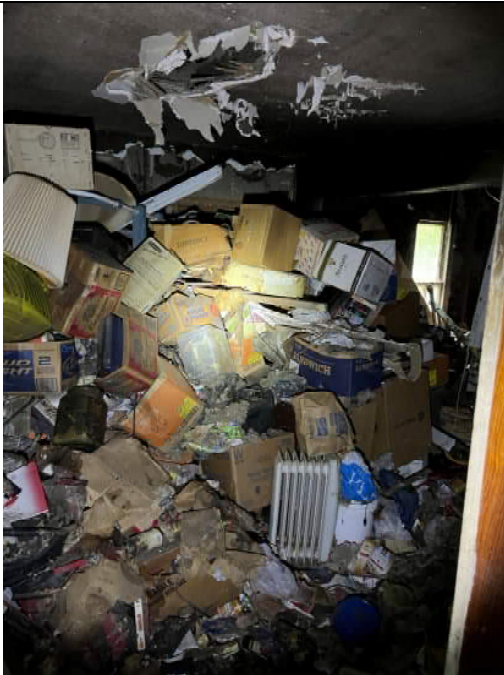
Photo 3: Contents of the residence

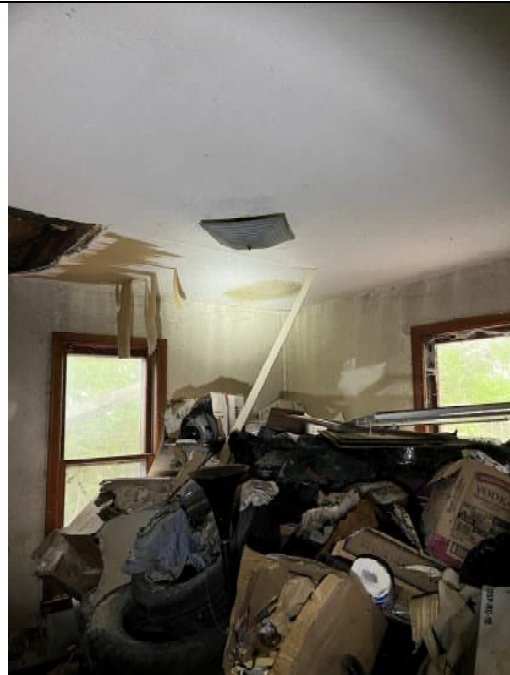
Photo 4: Contents of the residence

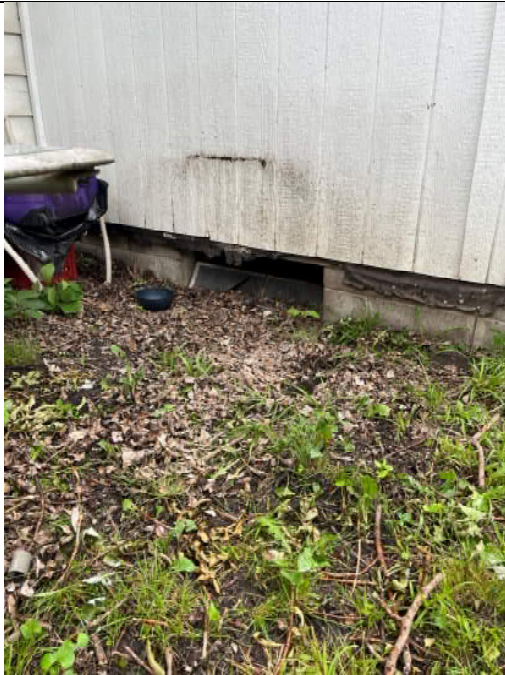
**Photo 5: Crawl space access**

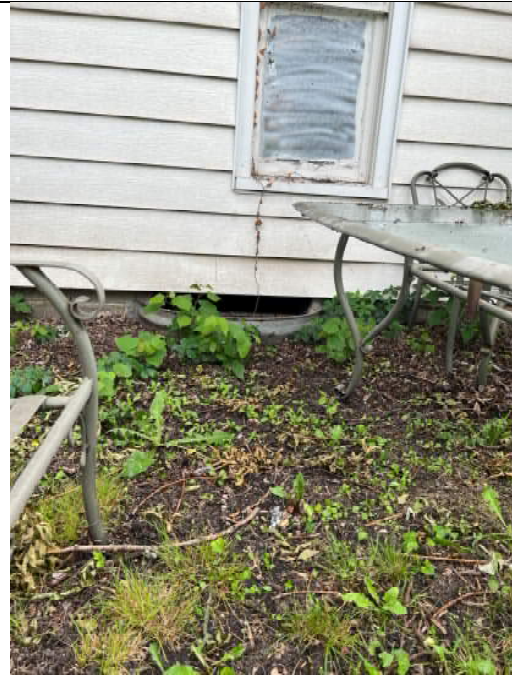
**Photo 6: Crawl space access**

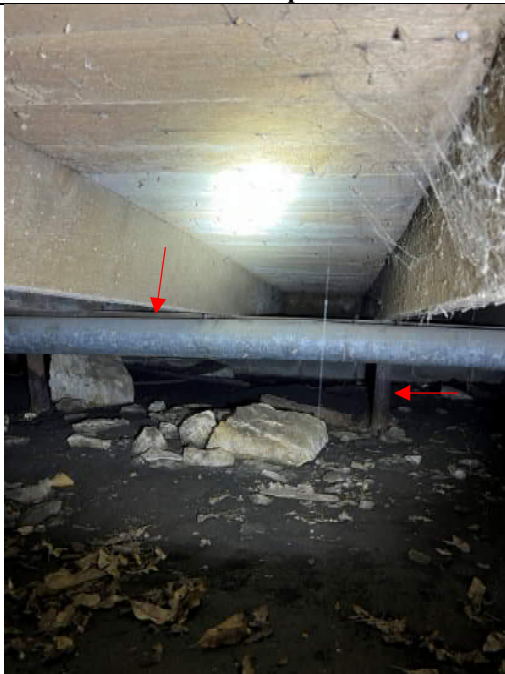
The floor framing in the northeast wing of the house was composed of 2x8 joists at 24" OC with a dropped beam at mid-span supported periodically by small steel pipe columns. The beam was not visible due to a smaller diameter pipe being located in front of it. It appears that the beam is composed of built-up 2x4s. It's not clear whether or not the pipe columns are supported on footings. To the west, a rectangular duct blocks visibility of the west half of the framing, but it can be seen that the south ends of the joists are discontinuous and that to the west of the jog in the east wall it's unclear whether or not the joists are supported by a beam. The remnants of an old stone foundation appear to be left behind. It's unclear whether or not those stones remain in service as part of the foundation. (Ref photos 7 & 8)

**Photo 7: Northeast wing framing. Note the beam and short post**

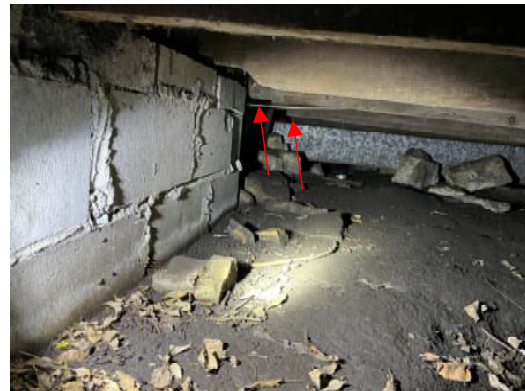
**Photo 8: Unsupported floor joists ends**

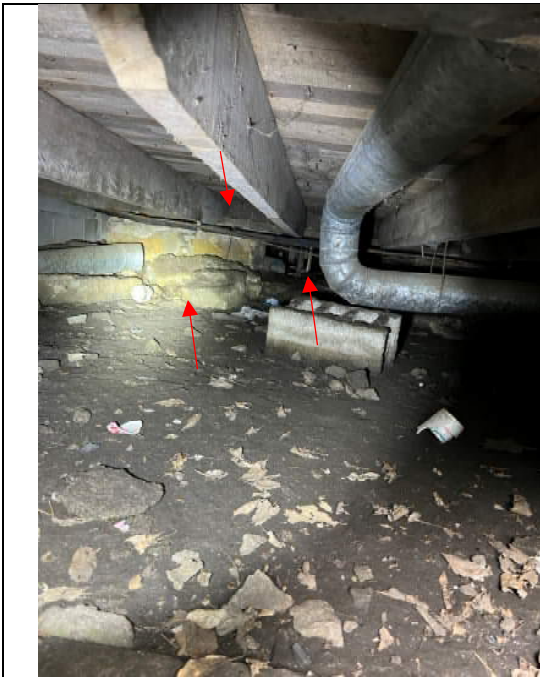
Through the southmost crawl space opening it can be seen that the joists span east to west and the near span is supported by a flush beam in the floor system. Past the flush beam, the floor framing was difficult to observe. More stone remnants are visible. Adjustable metal jacks can be seen throughout this wing of the residence supporting individual joists. The jacks may be supported by small foundation elements. (Ref photos 9 & 10)

**Photo 9: Southeast wing framing. Note the flush beam, stone remnants, and jack post**

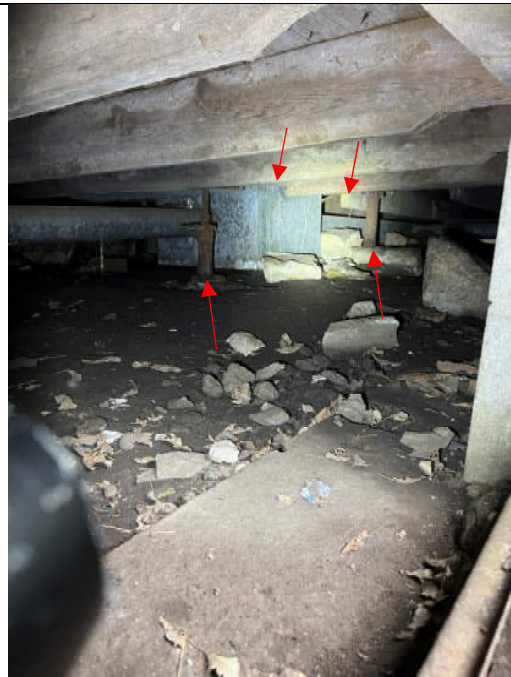
**Photo 10: Jack posts, unsupported joists from an alternative angle, and a cut joist**

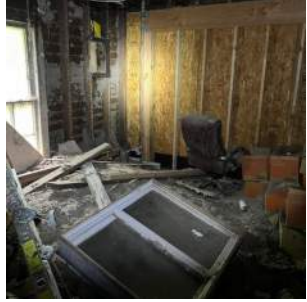
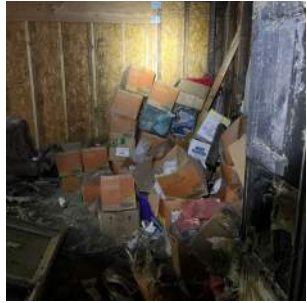
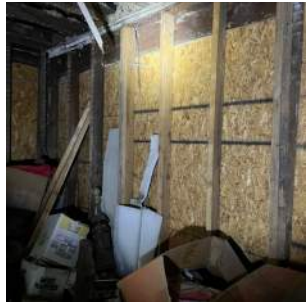
Number	Floor	Unknown	Description	Photos
1	First		The wall framing in the clouded area has been repaired due to fire damage, according to an Olathe building official.

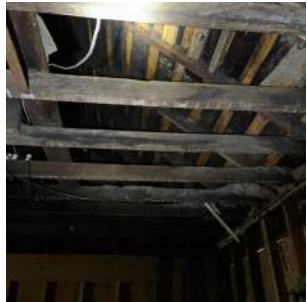
2			The gypsum board ceiling has collapsed in the clouded area leaving the top side of the floor covered in gypsum board and insulation. The ceiling and roof framing is visible in this area and appears to be mostly intact and was spared any major fire damage. No charring was observed in the members. Some older previous repairs were observed and appear to have been done to address fungal decay in several of the rafters and roof sheathing.

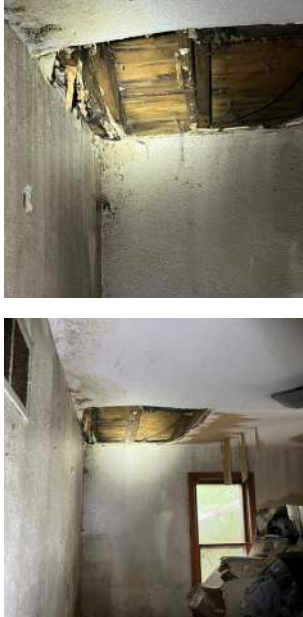
Number	Floor	Unknown	Description	Photos
5			<p>A hole was observed in the ceiling in the clouded area. Some of the rafters were observed to be decayed, but a hole in the roof wasn't able to be observed directly because the floor in the area directly below the hole did not appear to be safe to access.</p>

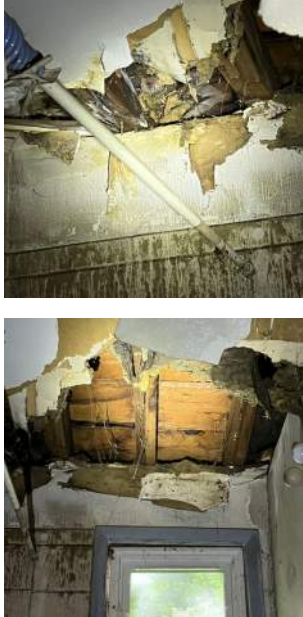
6			<p>A hole was observed in the ceiling in the clouded area. Some of the rafters were observed to be decayed, but a hole in the roof wasn't able to be observed directly because the floor in the area directly below the hole did not appear to be safe to access.</p>

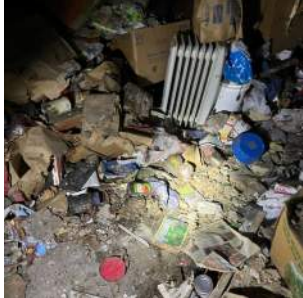
Number	Floor	Unknown	Description	Photos
7	First		The first floor framing in this area is visibly, significantly deflected downward. The contents of the house obscure the the floor to the north of the area making the full extent of the deflection unclear.

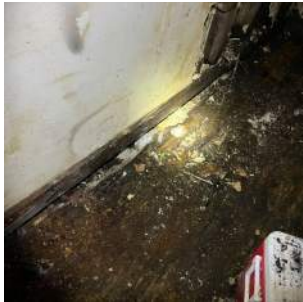
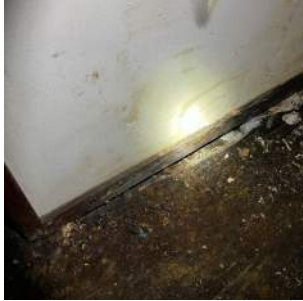
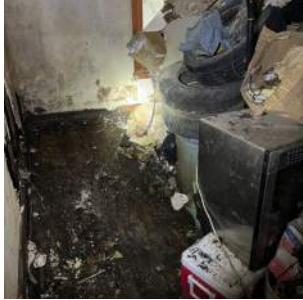
Some of the structural deficiencies identified in the Observations section (including Appendix A) above constitute partial collapse or lacking necessary support of the ground. The deflection observed in the floor framing in the southwest bedroom appears to be significant enough that the framing members may have collapsed into the crawl space and rested on the grade below. The structure near the center of the house, as viewed from the crawl space access locations, does not appear to have a complete load path, and some of the members appear to have been modified in a way that alters the load path.

8			The floor in the clouded area below the partition wall between the bathroom and southwest bedroom is substantially deflected and may be reasonably consider to have effectively collapsed down into the crawl space below. A large gap of 6" or more was observed below the partition separating the two rooms and the top of the floor's surface. The floor within the southwest bedroom was only visible at the east end of the room. The floor's surface to the west was obscured by the contents of the house.
