**STATEMENT OF UNSAFE OR DANGEROUS STRUCTURE (K.S.A. 12-1750)
LOCATED AT 413 SOUTH CHERRY STREET, OLATHE, KANSAS**

Re: Structural Condition Assessment
413 S Cherry St
Olathe, KS 66061

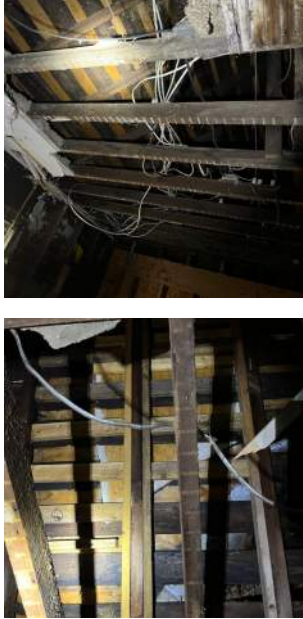
3	First		<p>The ceiling within the clouded area has a visible downward sag. The roof framing above was not able to be viewed due to the contents of the home.</p>
